**Press Release**

## **The African Water Facility Increases Access to Water Supply and Sanitation, Fights Cholera in Zimbabwe**

## **ANNEX - PROJECT TECHNICAL SHEET**

### **REHABILITATION OF WATER SUPPLY AND SEWERAGE SYSTEMS IN CHITUNGWIZA (2012)**

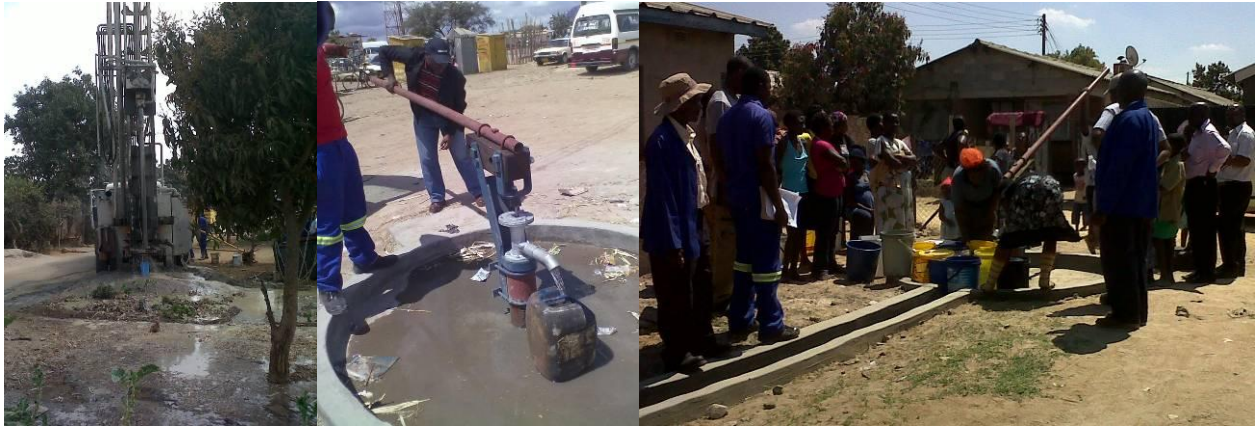
Photos 1, 2 & 3 show borehole drilling and equipping in SEKE to improve water availability and accessibility

The project was able to address the problem of water availability and access in Seke by drilling 10 boreholes of which 5 were successful and were equipped with Type B bush pumps. Control facilities used for water demand management were also attended to.

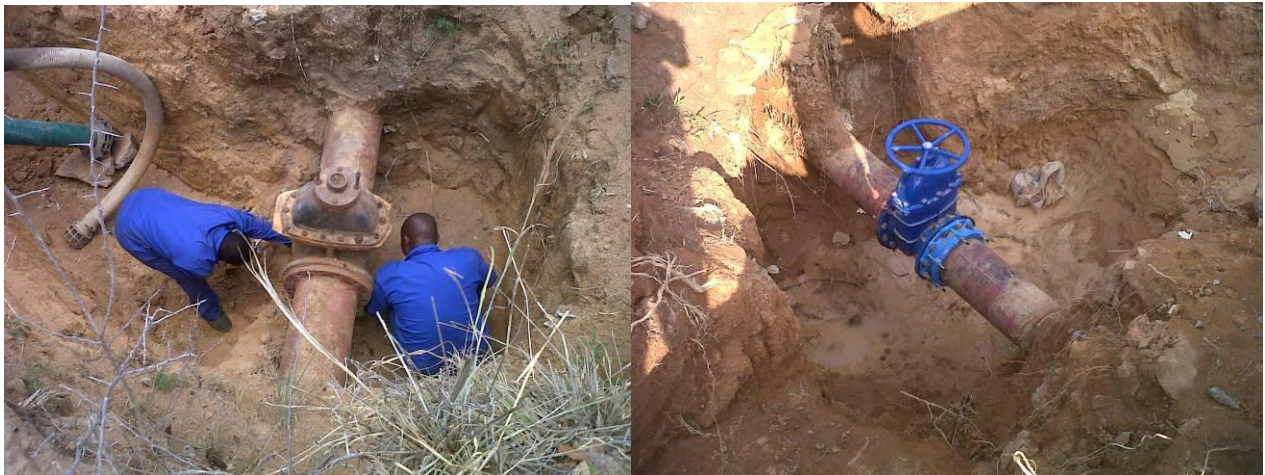
Photo 4 & 5 show replacement of old non functional control valves needed for water demand management

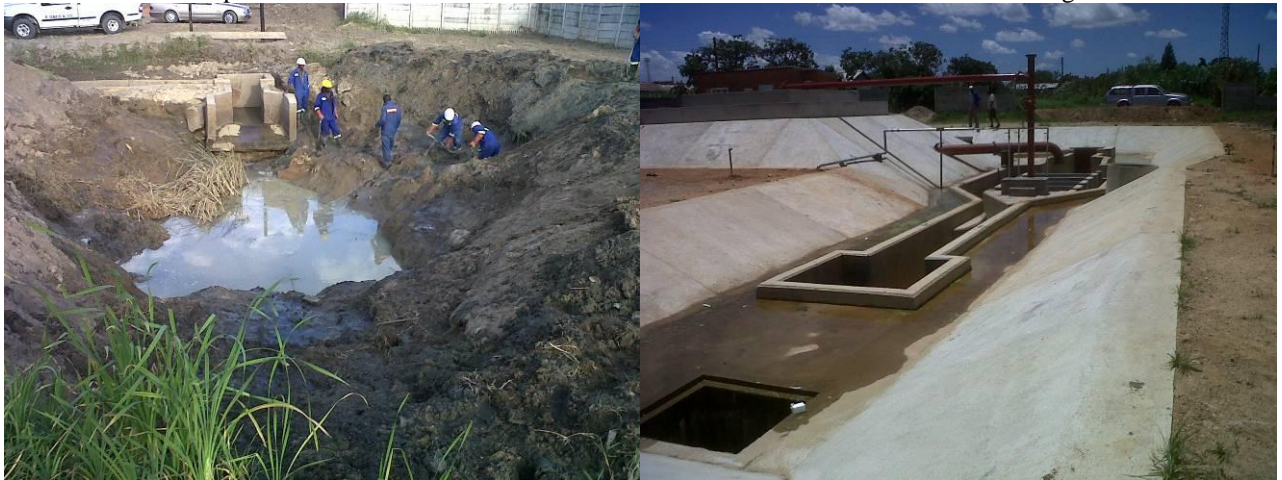
The Vertical Flow Grit Chamber used to trap sand before (photo 5) and after completion (photo 6)

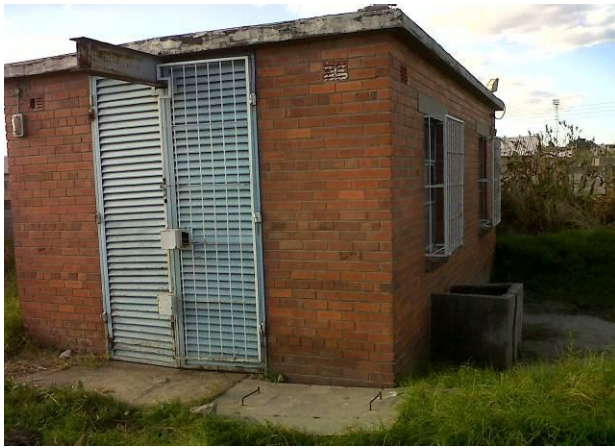
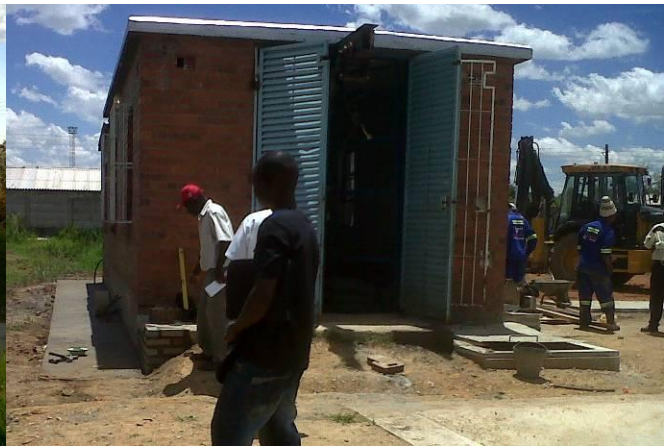
The Pump House building housing the pumping gear before (photo 7) and after completion (photo 8)

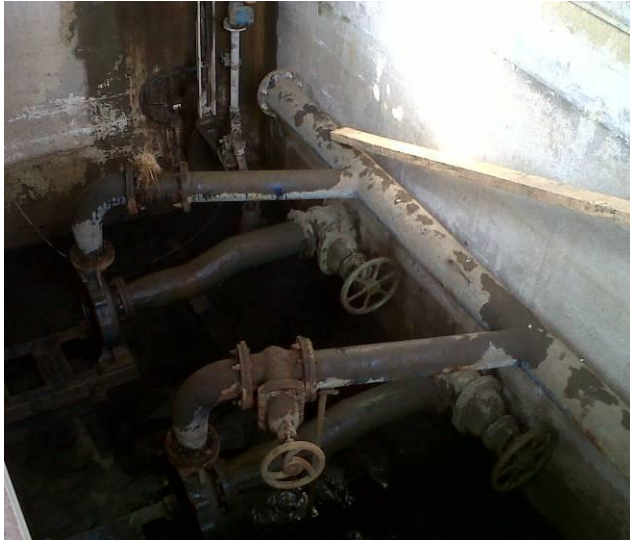
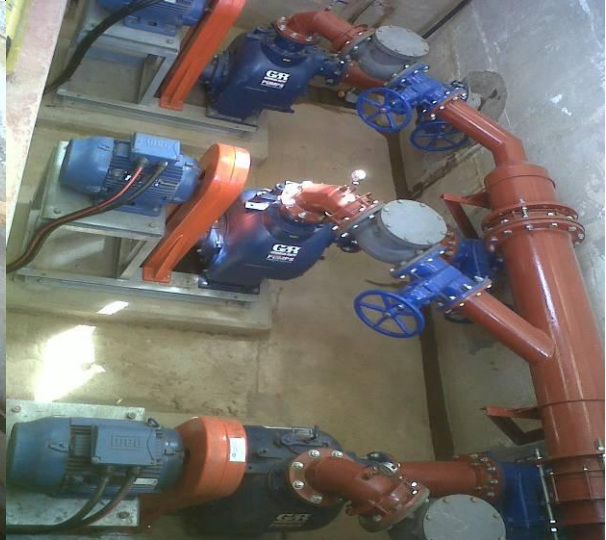
Pump Station No 1 showing once flooded equipment (left) photo 9 and operating new pumping gear in the drywell (photo 10)

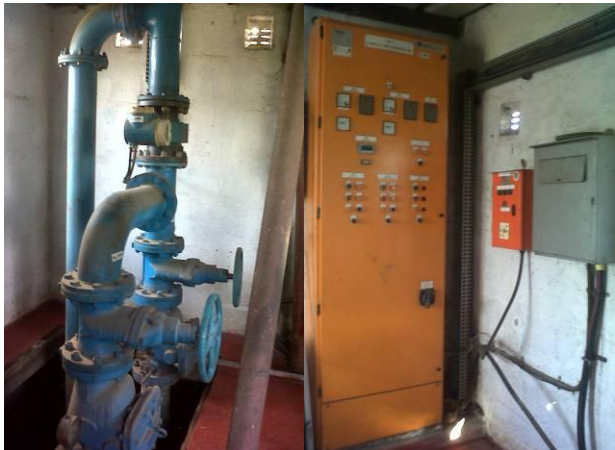
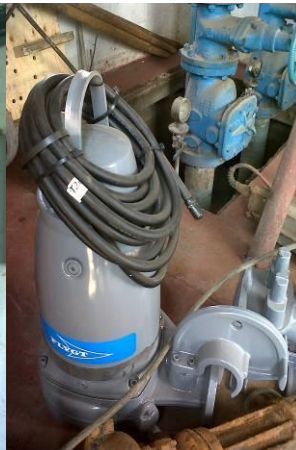
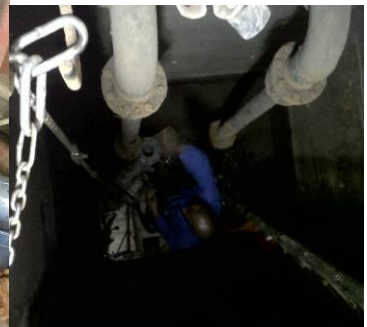
Pump Station No 2 showing existing piping and refurbished control equipment (left) (photo 11 & 12) and new submersible pumping gear (photo 13) and artisan fixing the new pump in the wet well (photo 14)

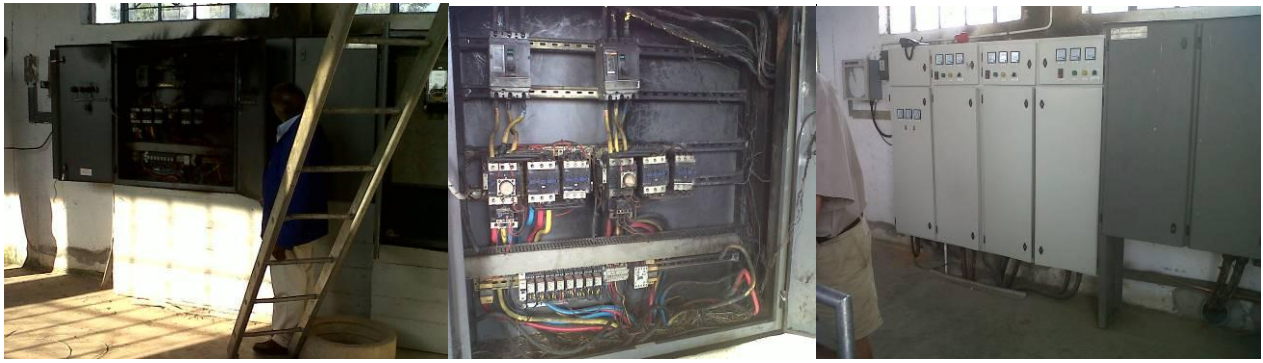
Existing burnt out pump control gear – left (photo 15 & 16) and the new replacement control gear (photo 17)

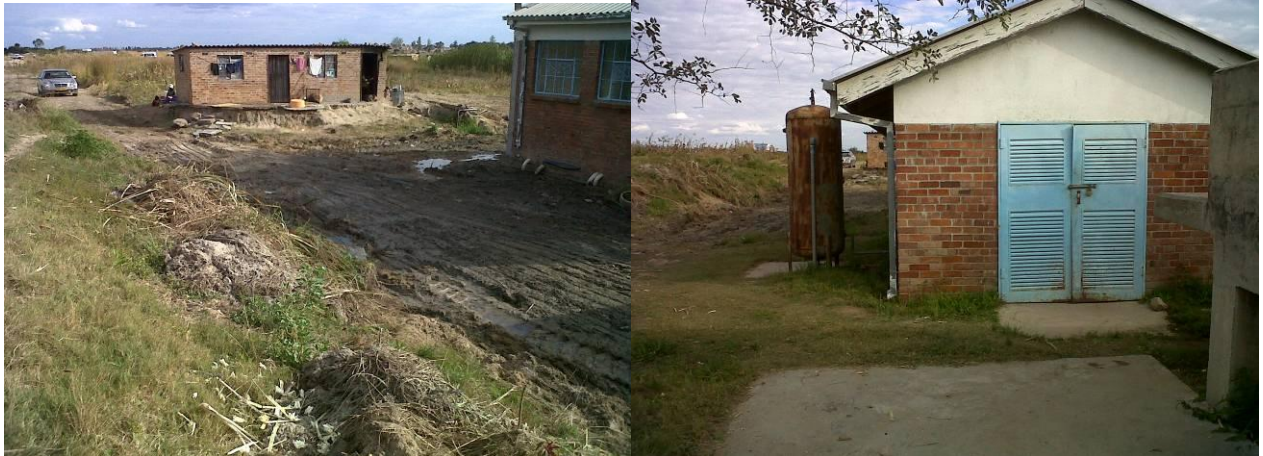
Existing Pump Station 3 building and attendant's house showing waterlogged ground condition (left photo 18). Photo 19 on the right shows the compressor room and pressure vessel used to operate the grit removal mechanism.

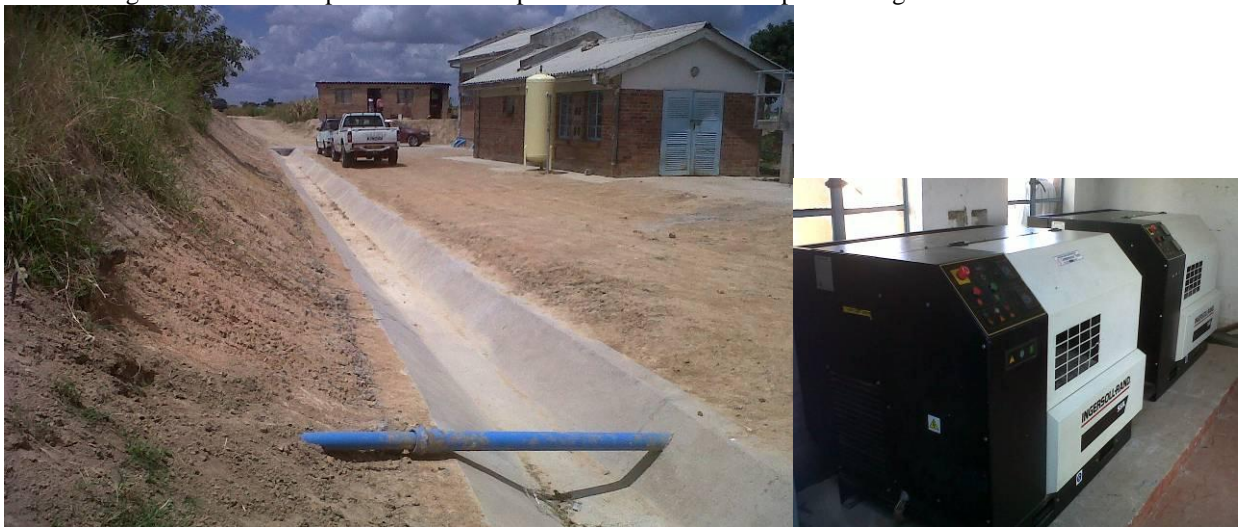
Pump Station 3 refurbished building and pressure vessel with new surface and subsurface drainage facilities (photo 20)  
Photo 21 shows the rehabilitated compressors

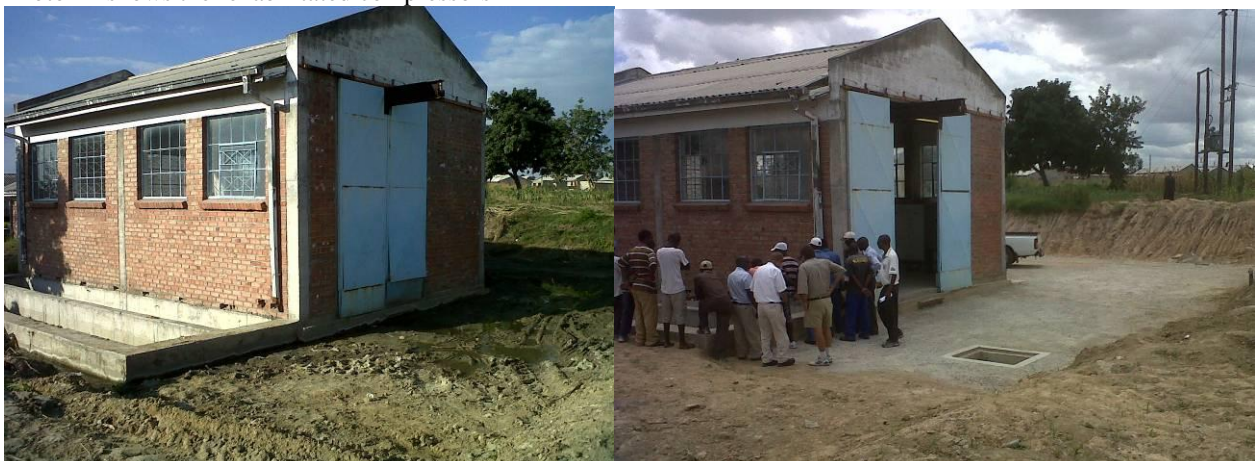
Pump Station 3 drainage and offloading bay pavement and drainage before and after (photos 22 & 23)

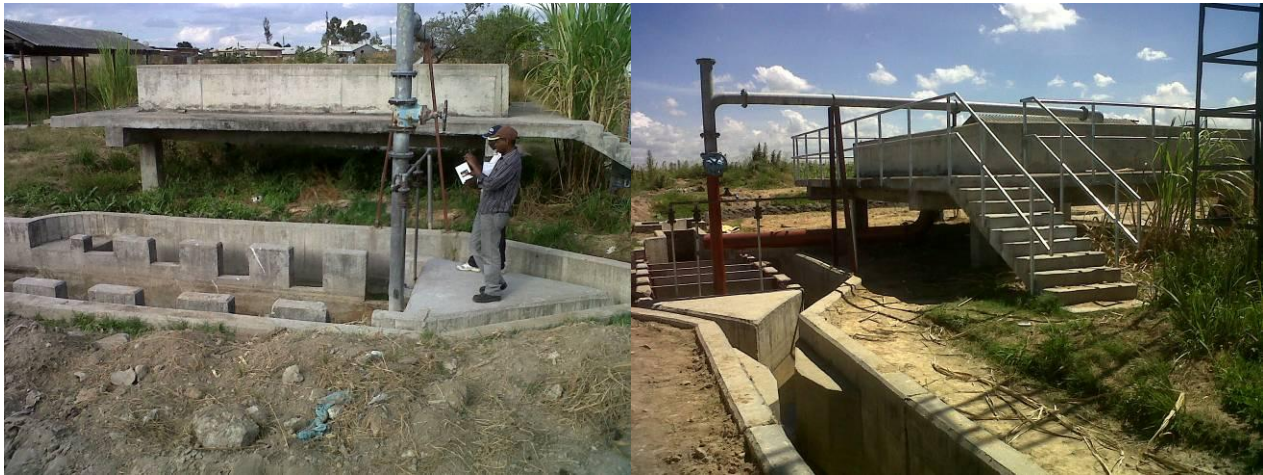
Pump Station 3 Vertical Flow Grit Chamber & Decanting Chambers before and after rehabilitation (photos 24 & 25)

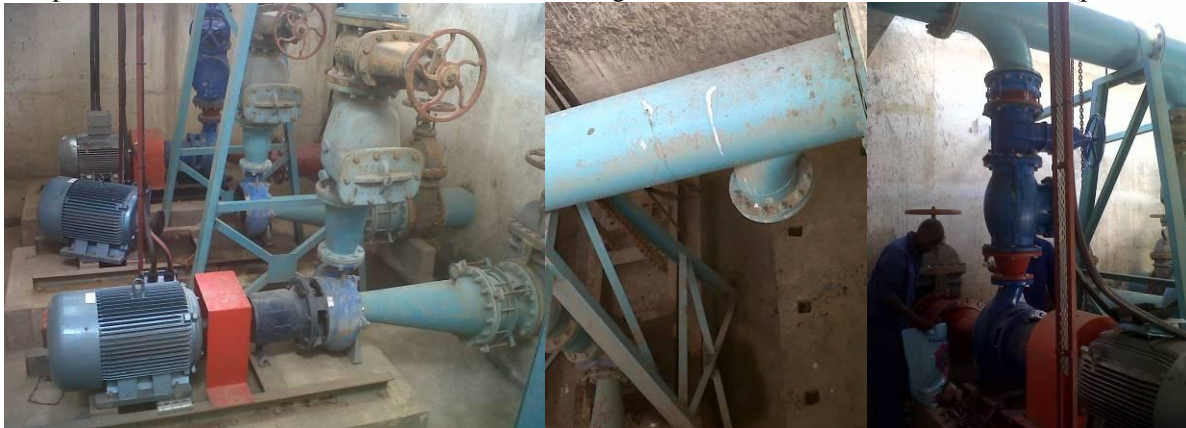
Pump Station 3 newly refurbished pump sets 1 & 2 and new installation 3 in the far end to the wall (photos 26). Photo 28 shows the new pump in greater detail.

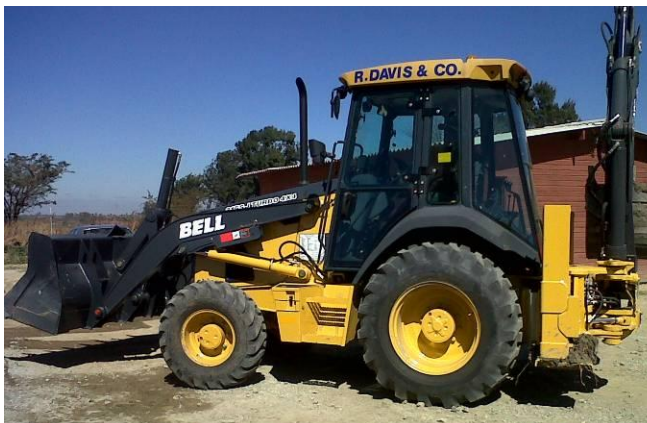
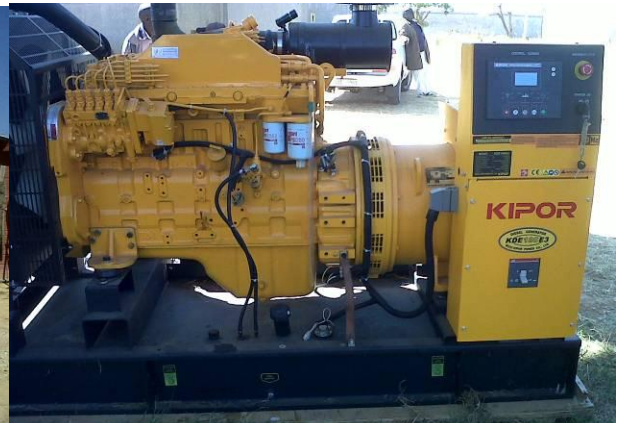
Photo 30 (left) shows the newly acquired Bell backhoe loader as part of capacity building  
Photo 31 (right) 110kVA generator at the water storage reservoir site to run the booster pumps during power outages

including sewer replacements involving pipe laying and connections to existing services. As part of capacity building, the municipality received a backhoe loader, 110kVA power generator and 5.5km of pvc water pipes (50mm to 400mm diameter), valves and fittings to be used in the replacement of aged pipes and accessories.

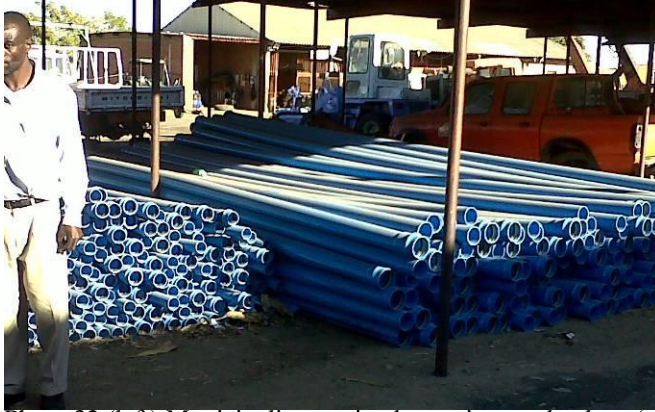
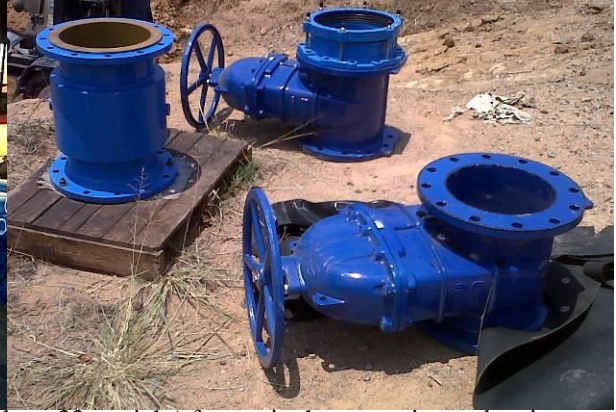
Photo 32 (left) Municipality received pvc pipes and valves (photo 33 on right) for use in the expansion and maintenance of the network.

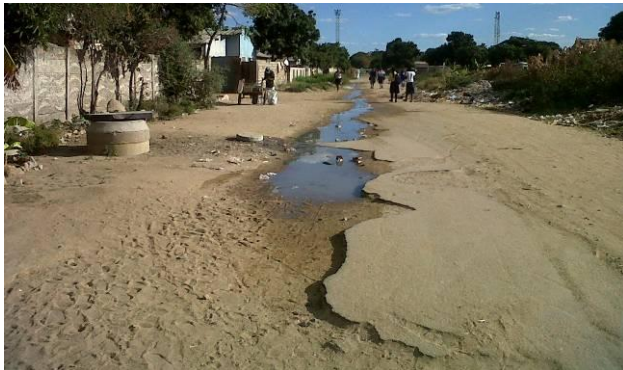
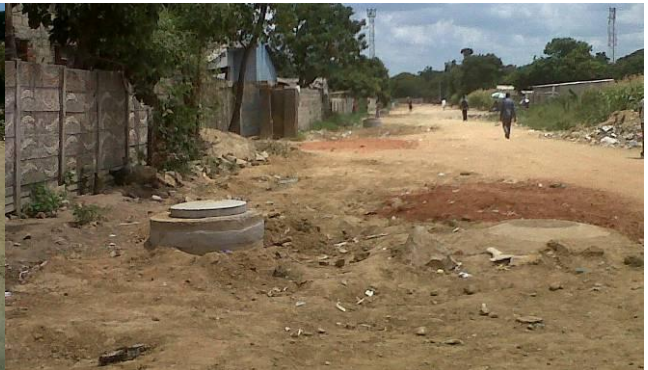
Blockages and overflows have been an everyday occurrence. These blockages have been caused by a myriad of reasons ranging from sand accumulation to undesirable debris in the sewage such as newspapers, plastic bags and others.

Photo 34: sewage overflowing down Dumukwa road before and photo 35 is after intervention

This project has been able to address all three specific objectives as mentioned earlier. The issues of blockages and sewage overflows in some of the badly affected areas such as along Roundabout to Post Office Road, Hombarume, Rufaro and Dumukwa junction, Ruzvidzo and Chiratidzo roads have been dealt with by replacing the affected dilapidated sewers by installing new house collector sewers. Sewage in St Mary's is now being directed to the three rehabilitated pump stations 1, 2 and 3 and being pumped away from the residences to the sewage treatment works at Zengeza 5.

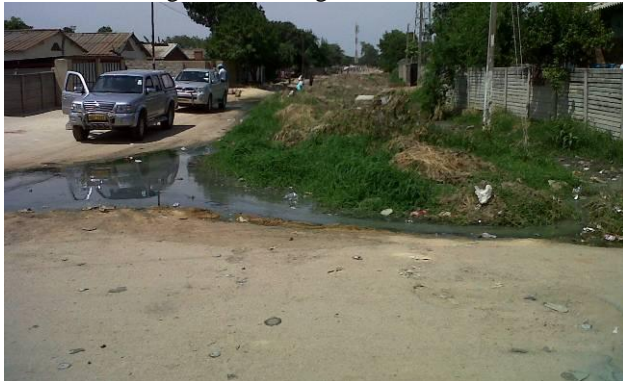
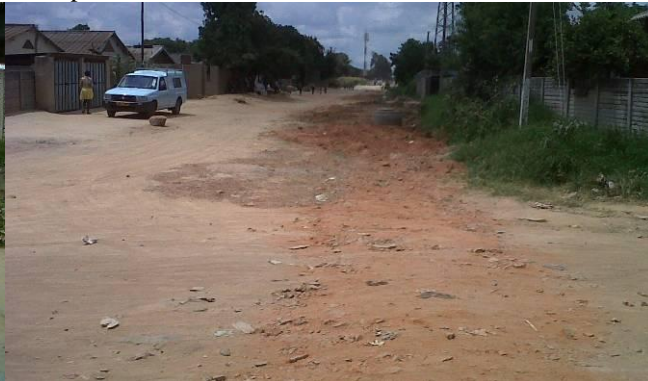
Photo 36: sewage overflowing at Dumukwa and Ingwe road junction before and after (photo 37) the intervention

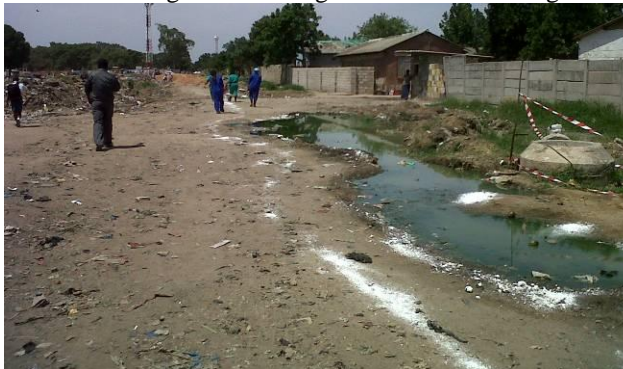
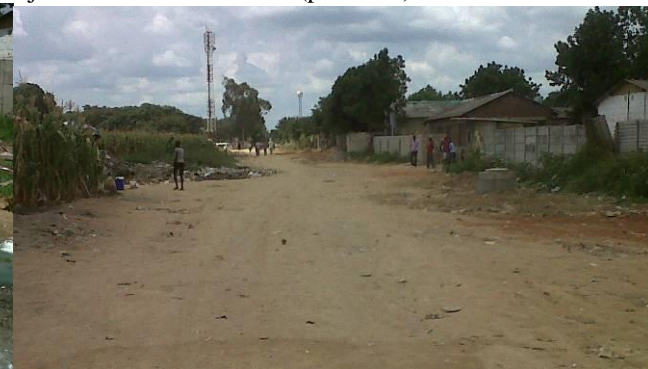
Photo 38: Stagnant sewage pools along Dumukwa before and after (photo 39) the intervention

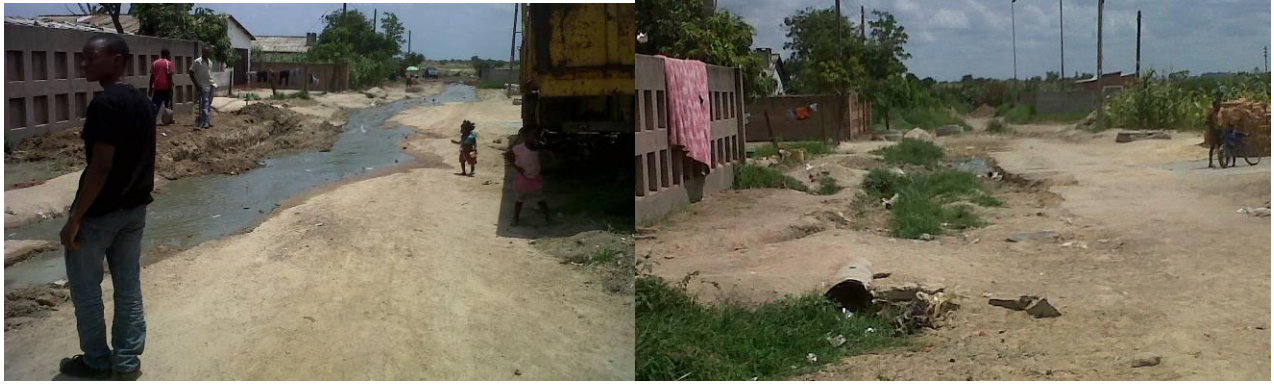
Photo 40: sewage overflow along Chiratidzo Road before and after (photo 41) the intervention

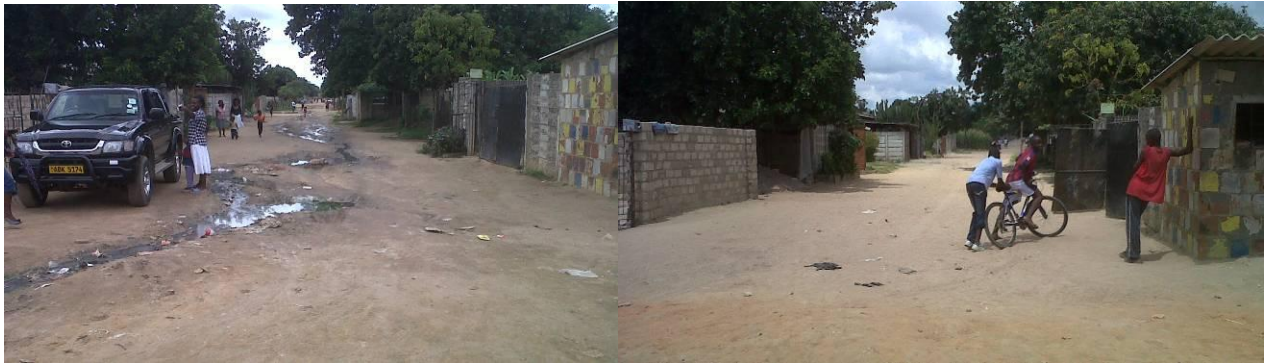
Photo 42: sewage overflow along Ruzvidzo Road before and after (photo 43) the intervention

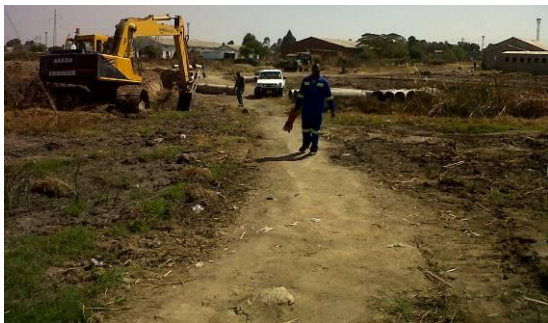
Photo 44: Sewer pipe replacement activity in progress
